# Manhole Inspection Summary

Manhole # S43A2\_016MH

**Location** Address: **1001 E Patapsco Ave**

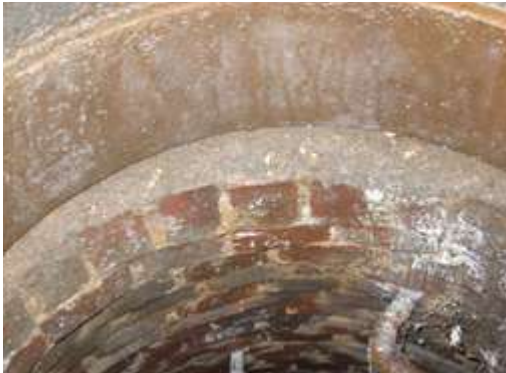
Defect 1

Offset: **2.5** (in.)

Frame offset

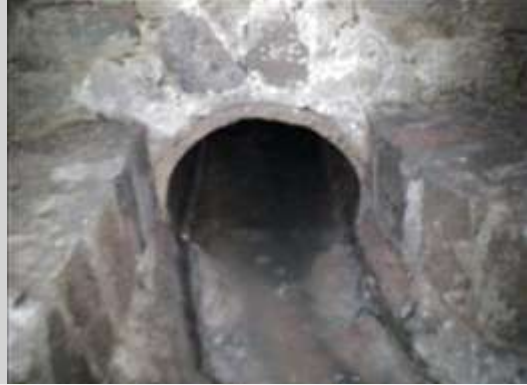
12 O'Clock Outflow

8 in. Circular Gravity Sewer  
Pipe Out @ 12 O'Clock

Pipe Height: **10.8** (in.) Rod and Bar (Angled)  
Pipe Material: **Clay** ☐ Pipe Lined  
Invert Depth: **8.65** (ft.) Flow Characteristics: **Fast**  
Deposits: ☒ None ☐ Mud ☐ Sludge ☐ Debris ☐ Grease  
Silt Depth: (in.) Deposits Extent:  
Infiltration: **None** Pipe Seal Cond: **Sound**

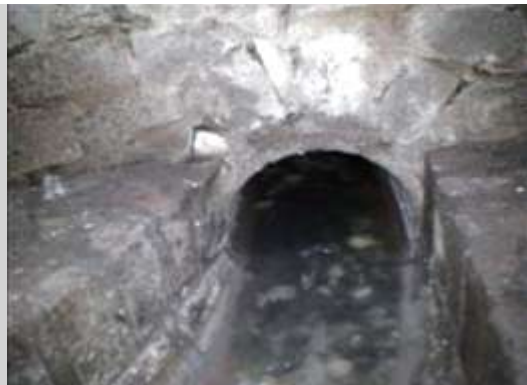
3 O'Clock Inflow

8 in. Circular Gravity Sewer  
Pipe In @ 3 O'Clock

Pipe Height: **9.6** (in.) Rod and Bar (Angled)  
Pipe Material: **Clay** ☐ Pipe Lined  
Invert Depth: **8.51** (ft.) Flow Characteristics: **Fast**  
Deposits: ☒ None ☐ Mud ☐ Sludge ☐ Debris ☐ Grease  
Silt Depth: (in.) Deposits Extent:  
Infiltration: **None** Pipe Seal Cond: **Sound**
